# **Selection, Evaluation and 5-Year Performance of Highway 1 Section Rehabilitated with Hot-In-Place Recycling Treatment**

Vipin Sharma, P.Eng. PMP  
Senior Pavements Engineer  
Tetra Tech  
Vancouver, British Columbia

This paper looks at the pavement evaluation, quality control and quality assurance testing completed during construction and current condition of the 5-year old pavement.

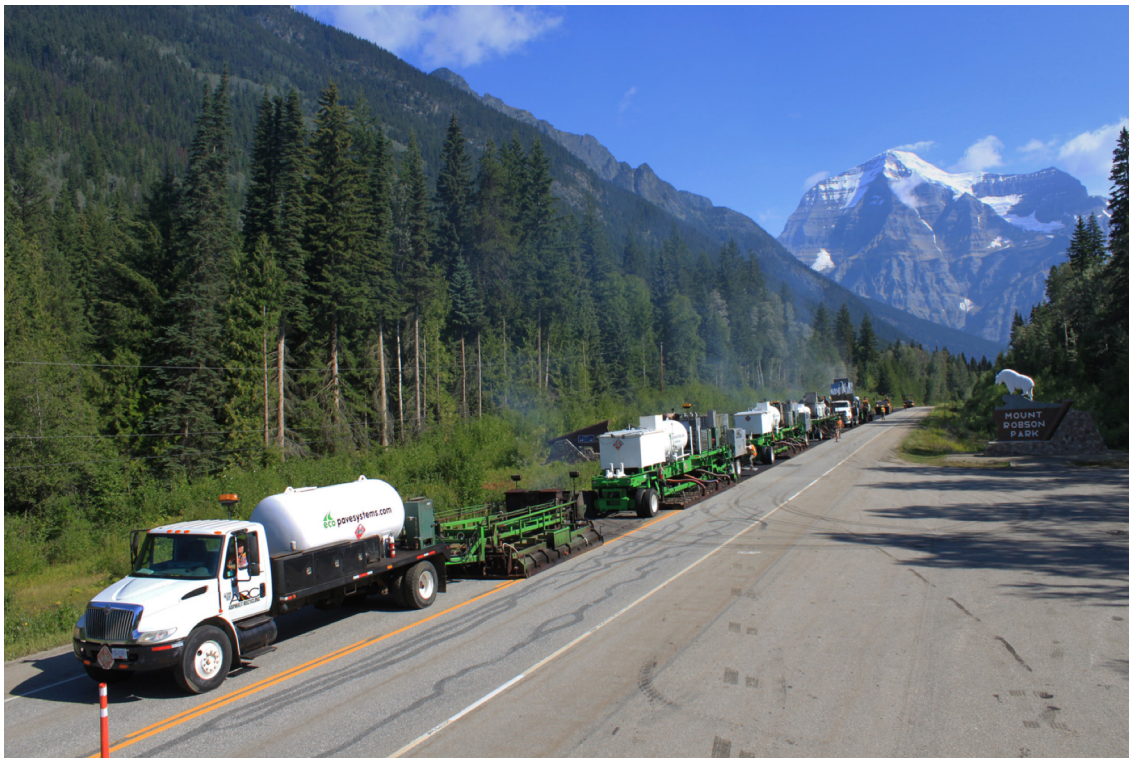
Ecopave Systems Inc. developed a new three stage HIPR train in 2014 that uses infra-red heaters to heat the pavement (Photograph 1), which results in significantly lower fumes when compared with the use of the propane heaters, and improved end product. As a result of the improvements in the equipment and processes over the last decade, up to 4 lane-kilometres of the roadway could be recycled in a single shift.

**Photograph 1. Latest Hot-In-Place Recycling Train**

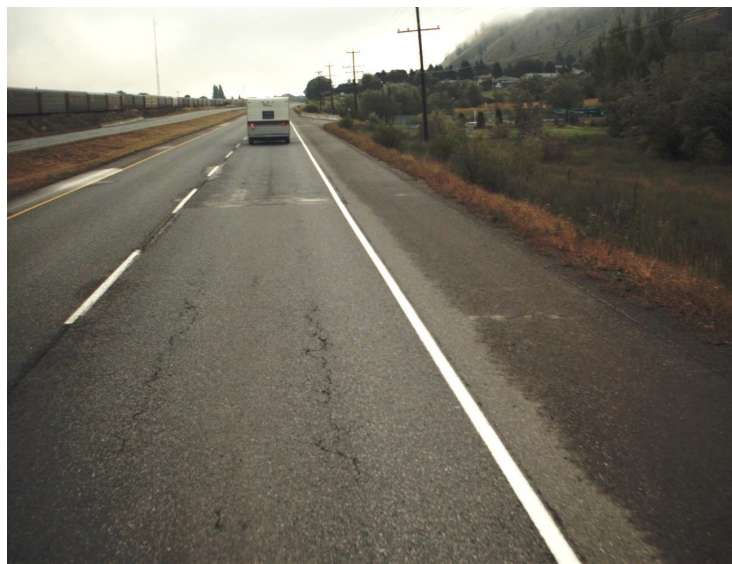
Photograph 2 shows the condition of the pavement surface prior to rehabilitation in 2009.

**Photograph 2. Pavement surface exhibiting wheelpath cracking and rutting in the eastbound slow lane at Station 14.37.**

The pavement surface was observed to be in fair condition with several localized poor areas at the time of pavement evaluation in 2009. Low severity rutting and bleeding were observed in the eastbound slow lane for majority of the project length. Moderate severity ravelling in the form of loss of surface fines was noted to exist throughout the project limits. Several localized areas with high severity alligator cracking in the wheel paths were also noted. High severity rutting with bleeding was noted in the eastbound slow lane adjacent to the intersection with the Vicars Road.

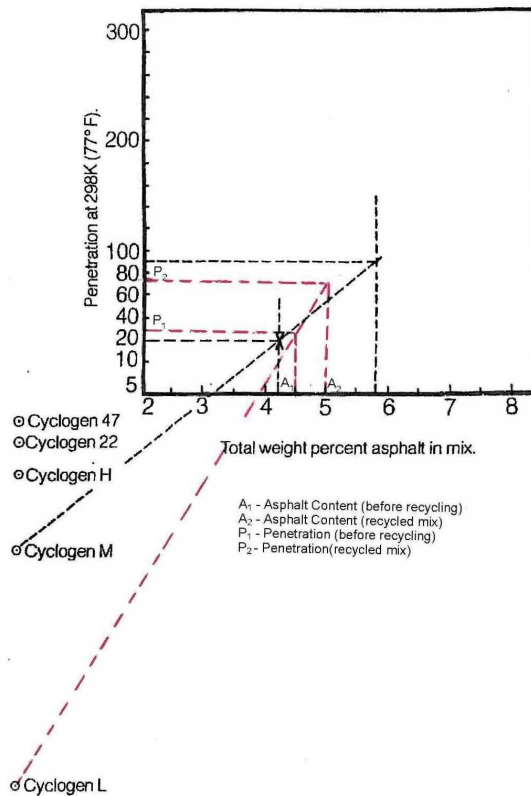
The penetration of the asphalt cement in the recycled admix was estimated using the Nomographs provided by the manufacturer of Cyclogen products as presented in Figure 4. Based on the review of the Nomograph plots, the penetration of the asphalt cement in the recycled asphalt mix was estimated to be about 70 dmm based on an average recovered penetration in the cores of 28 dmm.

**Figure 4. Nomograph for Estimating Penetration of Asphalt Cement in Recycled Mix**
